■ Appendices

Appendix A—Injuries

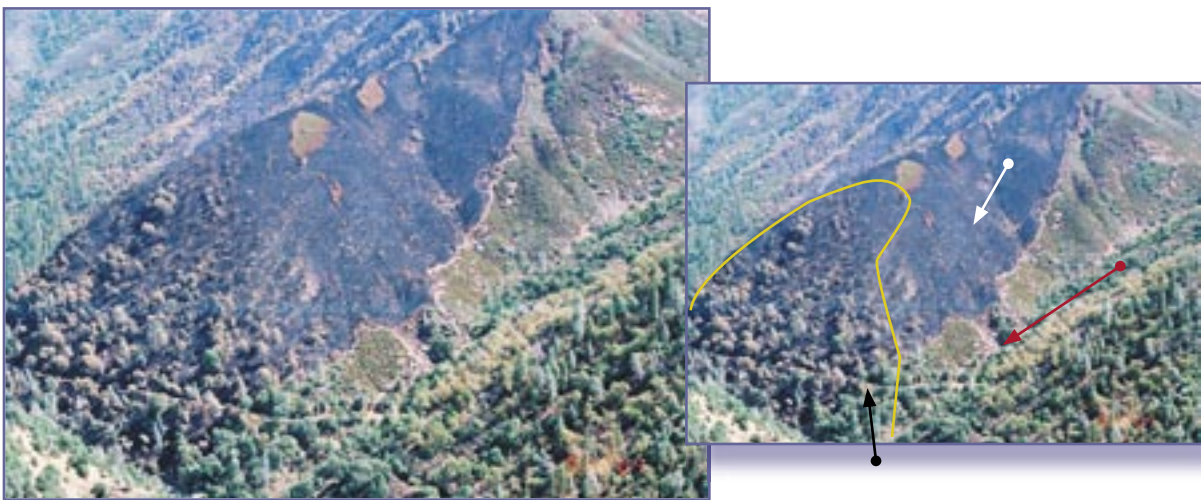
Photo H-3. View of west aspect slope (yellow line) shown in lower left corner. Drew Creek in right of photo (red arrow). South aspect (white arrow) above Drew Creek visible above it. Ridge and fuel transition from west aspect to south aspect visible just left of center. Accident site (black arrow) below road along right flank near bottom of photo.

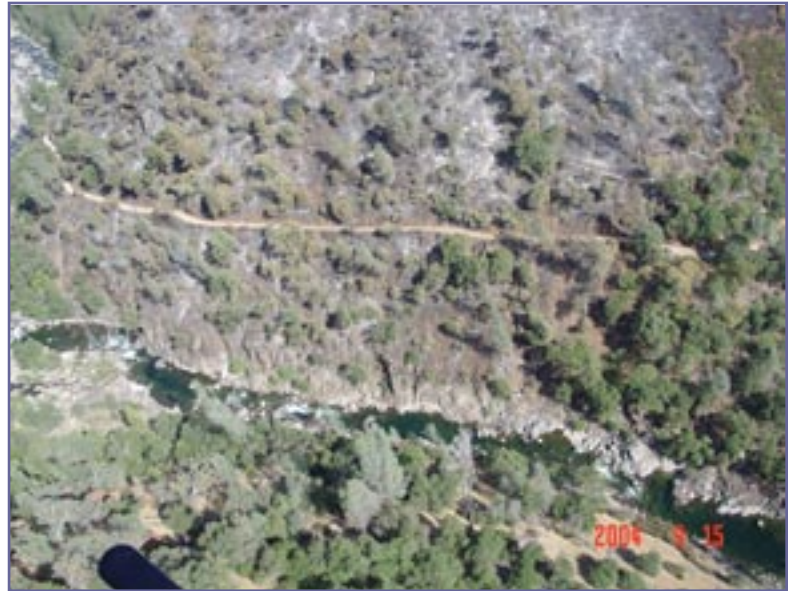
Macro burn indicators above the road, including degree of burn indicators, ash deposits and the relatively close alignment of the right flank above and below the road at the time of the accident indicate that the fire above the road moved up-slope and toward the south at a faster pace and burned hotter than below the road. This increased lateral spread indicates that fuel continuity and variations in the winds played a greater role in the spread of the fire above the road on the west aspect. This is consistent with wind conditions noted during the week and a half after the fire (see conditions section), smoke conditions noted during the final frames of the air attack video taken about 15 minutes prior to the accident and comments from the air attack expressing concern about the fire hooking below the retardant line on the right flank. Based on post-incident wind observations, this increased fire spread to the south would be expected to increase higher up on the slope.

Photo H-5. View of west slope showing heavy deposits of white ash above the road consistent with hotter burning and higher fuel loads in this area. Below the road only isolated small patches of white ash are present with the decrease even greater near and at the accident site.

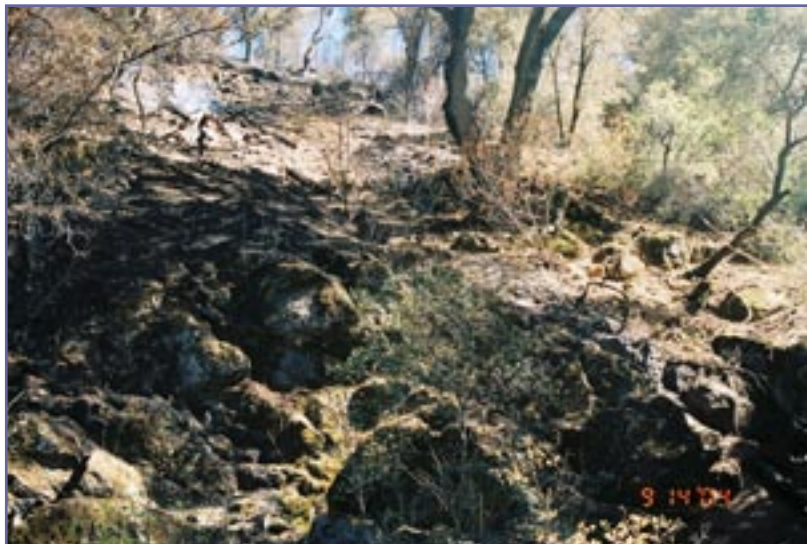
Photo H-6. View just up-canyon from accident site. View shows fuels and topography where fire was backing into wind toward accident site at right out of photo.

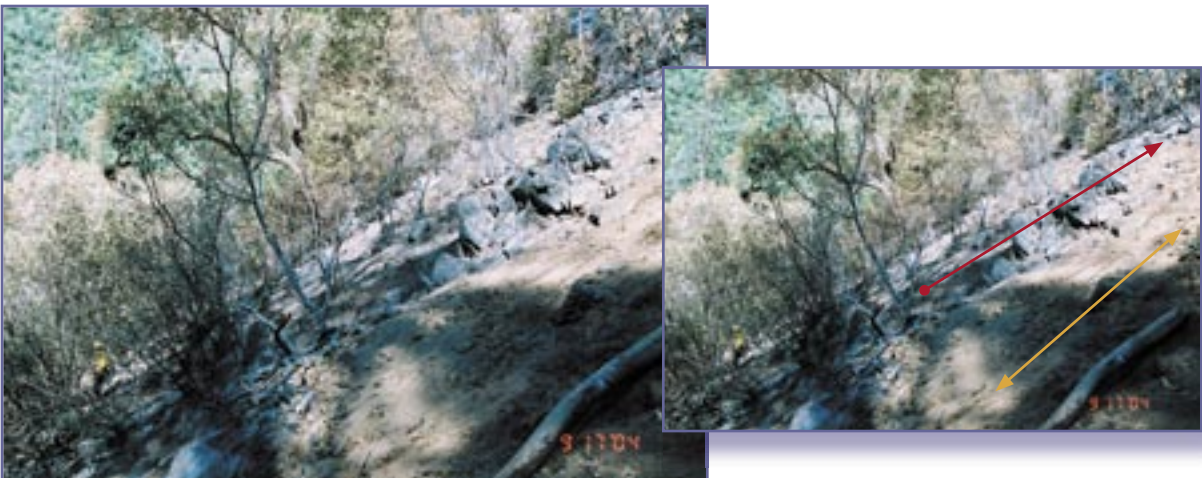
Below the toyon bush and gray pine and inside the proposed line location was a moderately heavy patch of mixed toyon and live oak brush which covered an area about 45 feet up and down the hill and 28 to 30 feet across the hillside. Below this brush patch the undergrowth turns to scattered live oak brush, toyon and oak trees with leaf litter and some downed limbs. Below this initial transition from the brush patch, the area opens up to patchy brush, oaks and leaf litter.

Photo H-9. View of lower end of brush patch showing beginning of run (red arrow) in brush up-slope. Constructed handline (yellow arrow) located in right lower corner.

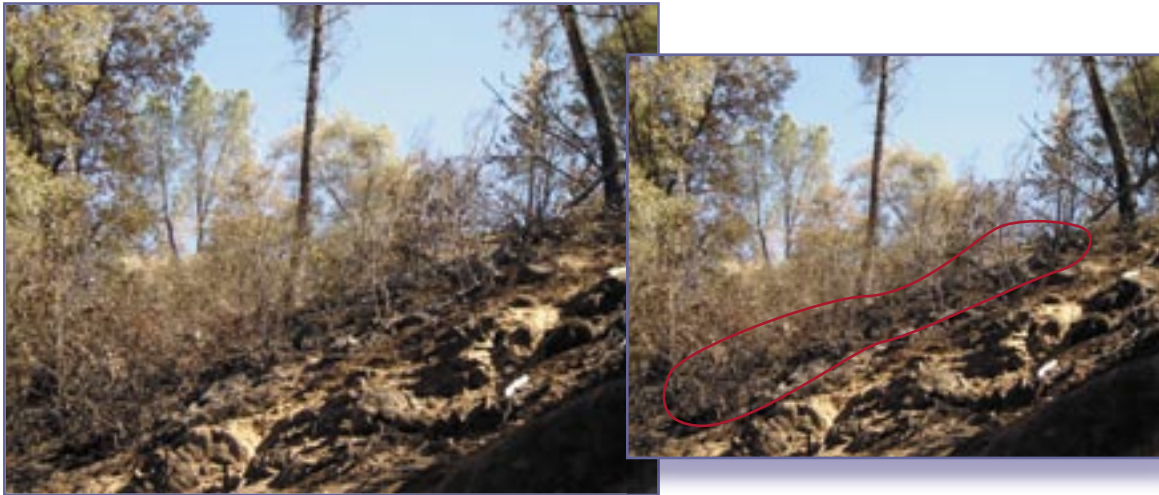
Photo H-10. View of brush patch (red line) which burned off just inside line location directing convective heat towards the upper end of the line near the road.

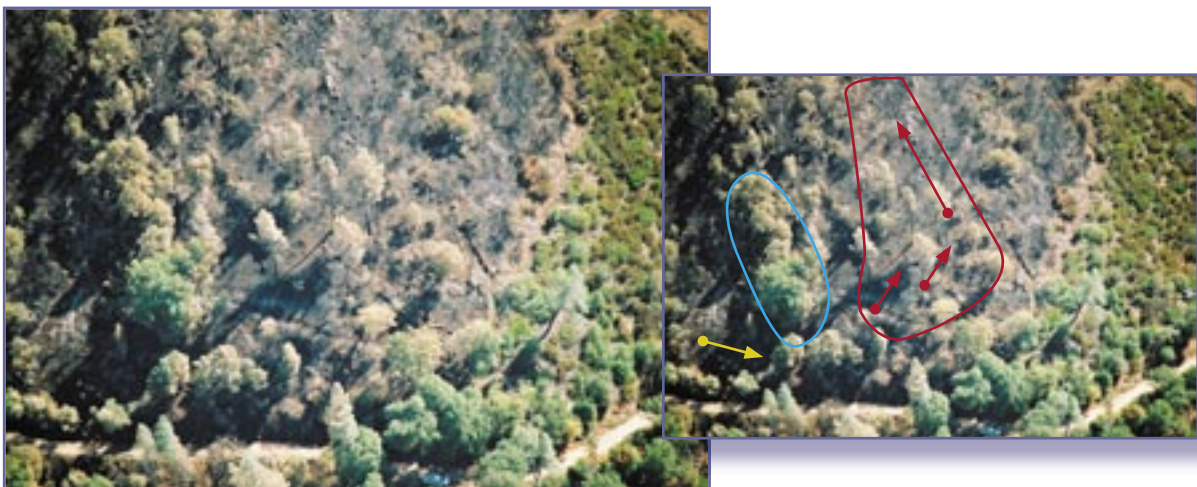
At the same time the fire was spreading cross-slope below the road, fire had established itself above the road and spread into a standing snag about 80 feet tall. The snag was located about 30 feet to the north of the proposed line location, about 40 feet up-slope of the road. This snag was observed just prior to the accident by a member of Engine 43 to have been burning about 40 feet up.

Photo H-11. View of area above the road and above accident site. Green trees visible to the left edge of photo above road is area of possible helicopter water drops (blue line). In center of photo is area which burned hot (red line) and rapidly (spread direction shown in red arrows) prior to and during accident events. Burning snag (yellow arrow) was located below and to the left of bright green tree above road in lower left corner of photo.

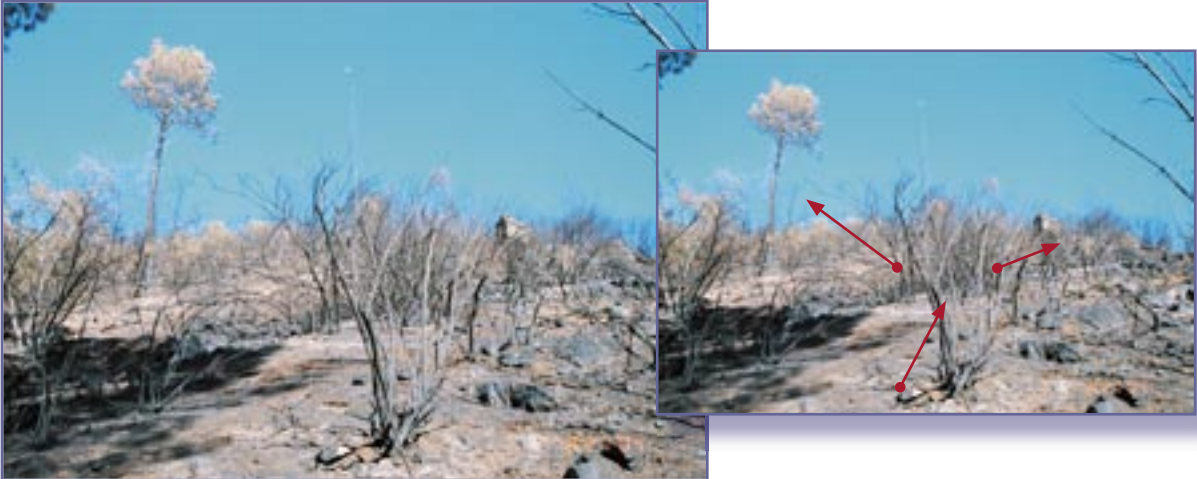
Photo H-17. Photo taken from ridge above road and accident site, which separates the west slope and the south slope. View is up-slope with west slope to left and south slope to right. Photo shows path where fire turned up-slope/ridge (red arrows) and degree of burn. Pine tree in upper left corner shows needle freeze indicators of fire coming up-slope from this location towards it. Fuels changed in this location from leaf and needle litter with patches of brush to consistent chamise brush field to right of photo.

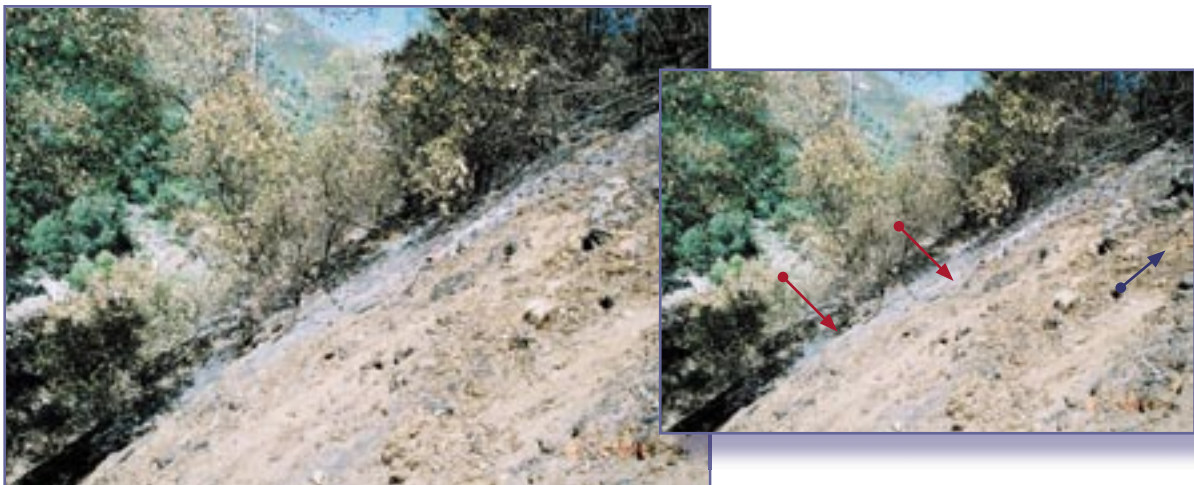
At the same time as the fire activity on the cut bank above the road, the fire below the road, which had been backing cross-slope and into the wind on the lower quarter of the slope, made a rapid run cross-slope to the south and up-slope. This fire spread directly toward the lower four members of the Helitack 404 crew. Burn indicators show that this fire spread remained initially in the surface fuels and moved rapidly under the brush present in scattered locations in this area.

Photo H-18. View from lower third of slope below the road at accident site looking from south to north cross-slope towards the direction where Helitack Captain Winger indicated the fire run had come from (red arrows). Chain saw work visible on right edge of photo and near center of photo (blue arrow).

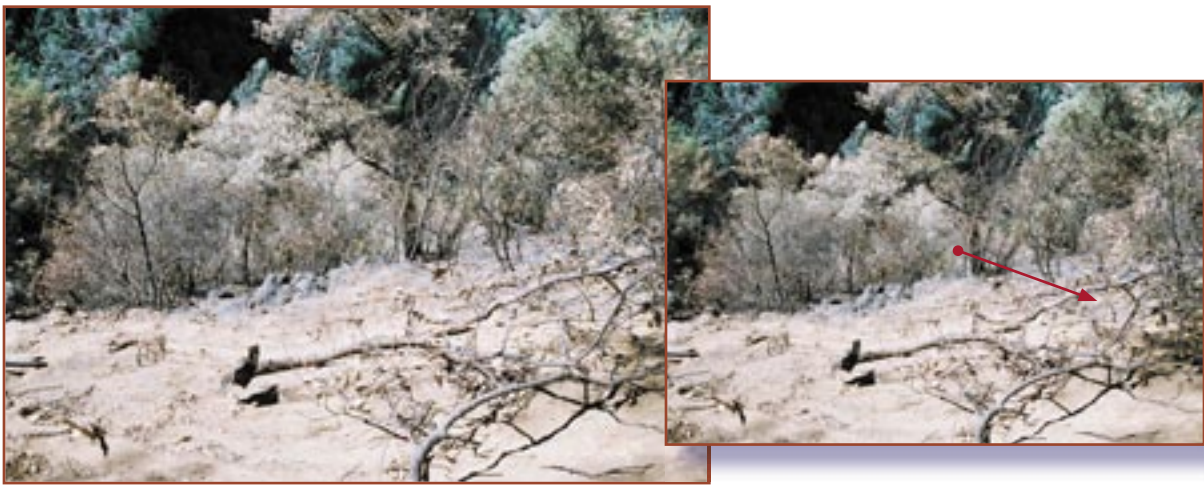
As the fire on the lower one-quarter of the slope below the road reached the bottom of the mixed brush patch of toyon and live oak approximately 28 feet inside the line location, burn indicators show that intensity, slope and fuel continuity (both surface and brush) provided enough heat to lift the fire into the brush itself. The consistent up-slope, and slightly to the south (right), burn pattern shows a rapid and hot torching run of this brush patch (45 feet up-slope) with most of the heat vectoring up-slope to the right and across the upper portions of the line construction where two members of the Helitack 404 crew were attempting to escape up-slope to the road.

Photo H-19. View from line location down-slope with brush patch visible to center and right of photo. Fire spread up-slope (red arrow) toward the location from which the photograph was taken and from the downhill right center of photo.

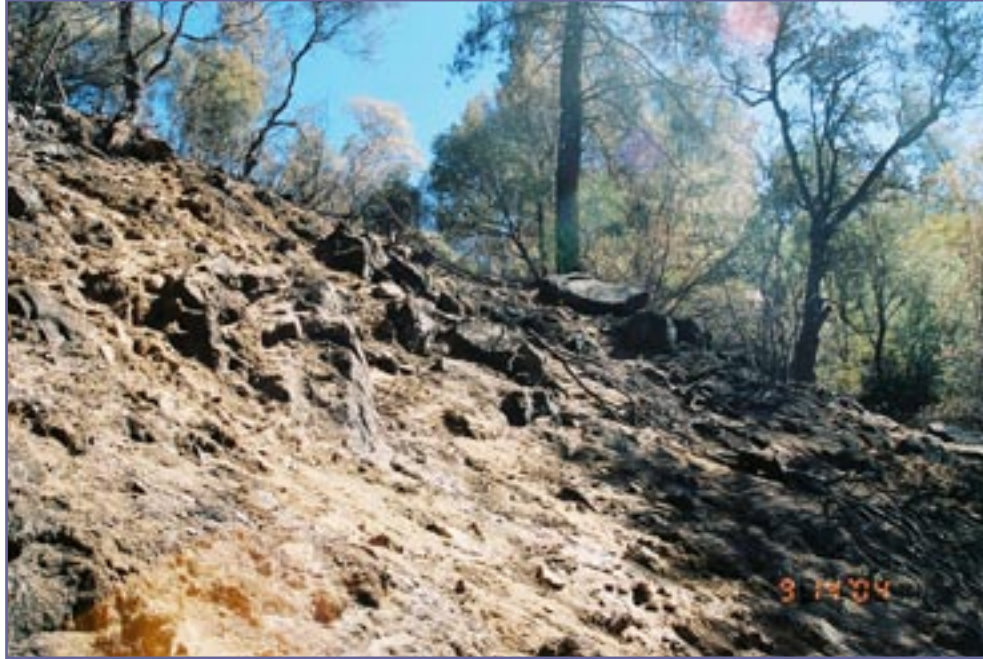
Photo H-27. View up-slope and from line location showing rock outcrop, located above body recovery site that line passed over.
